Inspection Report

Mine Name: Black Knight
Operator Name: GoldTerra, Inc.

Permit number: S0150078
Inspection Date: March 30, 2007
Time: about 12:00-12:30 PM

S0150078, Black Knight Mine, GoldTerra, Inc.

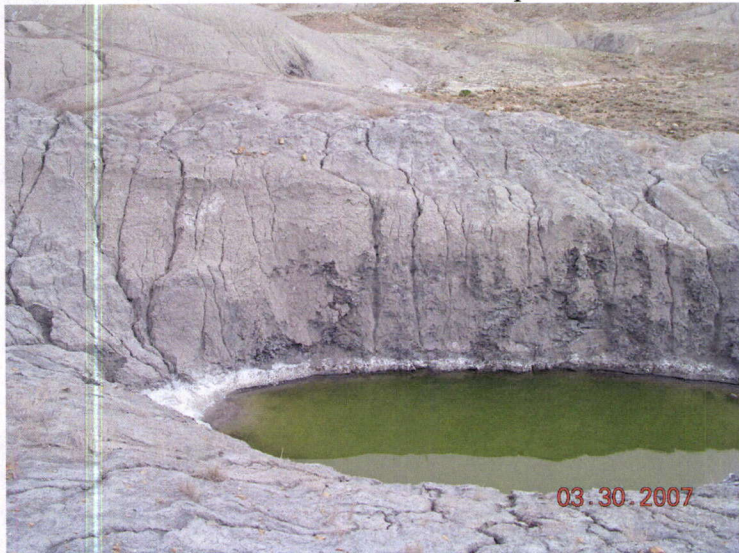
The disturbance consists basically of a pit around which the excavated material was piled (see photos). I could not tell that there had been any recent activity.

Photo 1. A portion of the pit that has been excavated. This picture and Photo 3 form something of a panorama.

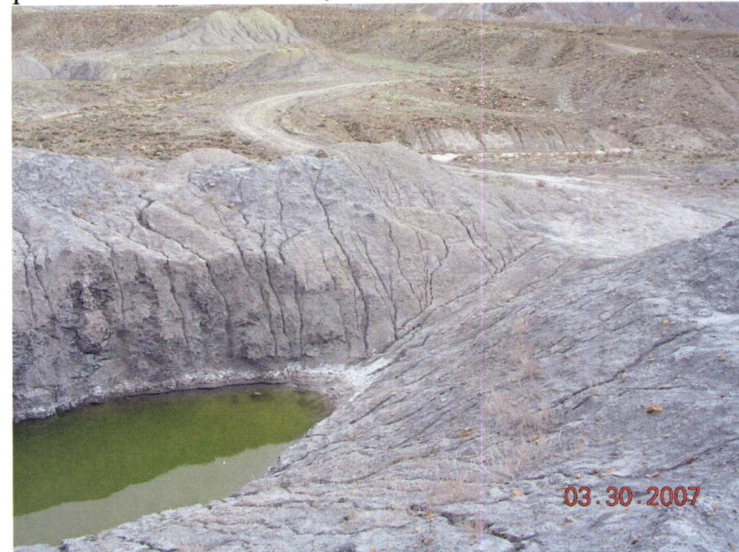
Photo 3. Another view of part of the pit. Also note the access road.

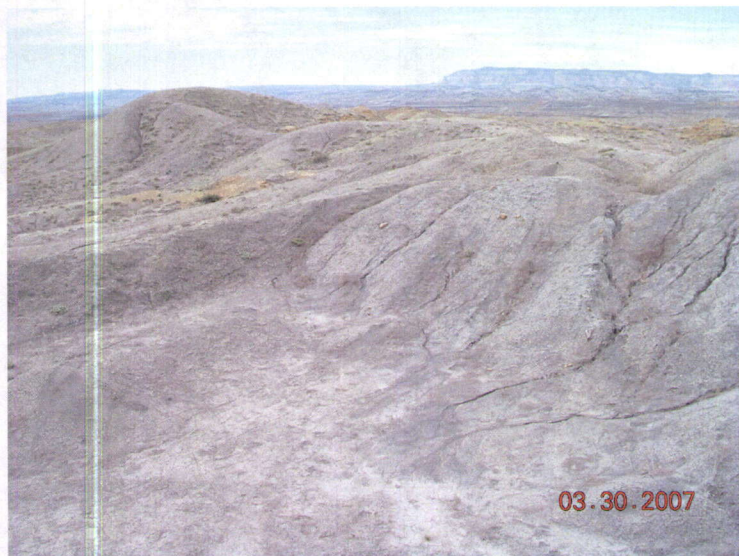
Photo 2. Some of the material excavated from the pit.

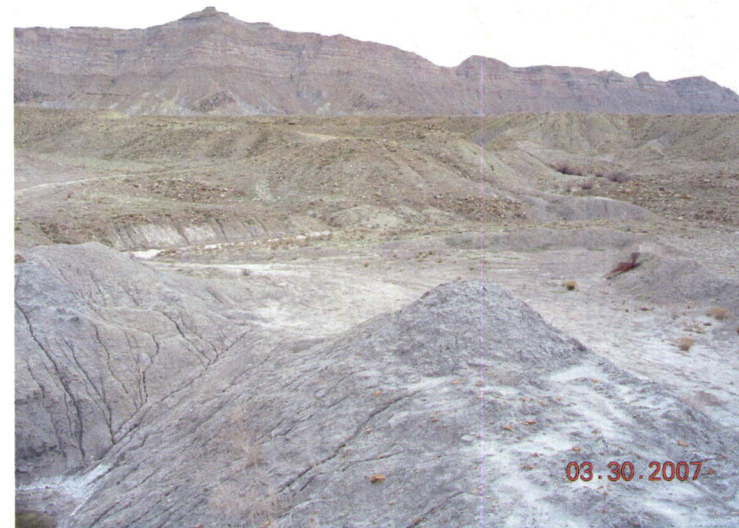
Photo 4. Another view of some of the excavated material.
